**State of Louisiana  
Department of Coastal Protection and  
Restoration  
Operations Division**

## **2010 Annual Inspection Report**

### **DELTA WIDE CREVASSES (MR-09)**

October 7, 2010  
Plaquemines Parish

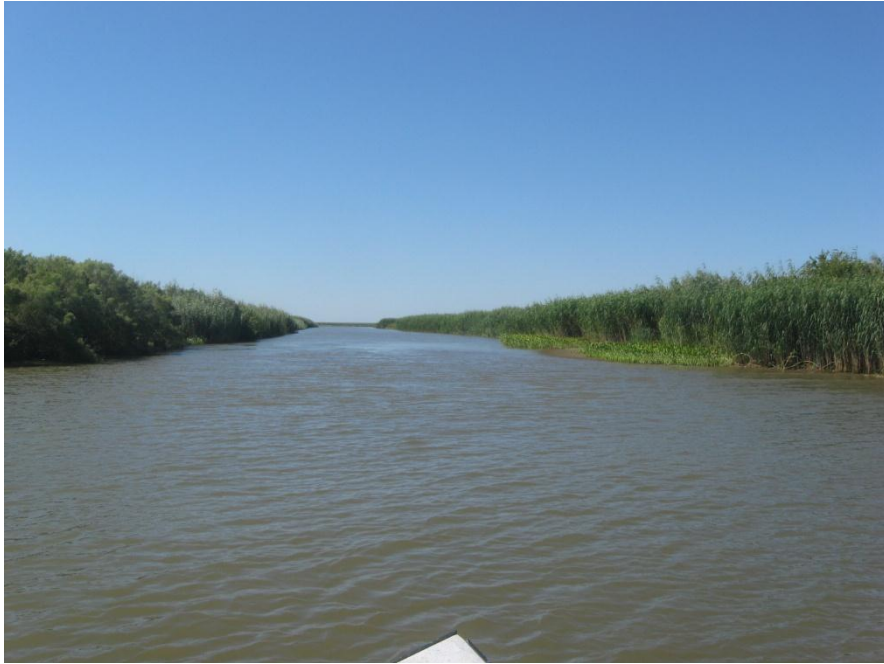
- E. Crevasse No. 12: (2,000 ft. X 75 ft. X -8.0 ft. NAVD 88) Despite being located off of the main channel, this crevasse appears to be functioning very well. There is sufficient current to carry sediments to the inner section of the bays and lagoons despite maintaining only slightly more than half its original depth. This crevasse had been originally dredged in (1999).

Crevasse No. 12 (view 1) Looking into crevasse from South East Pass.

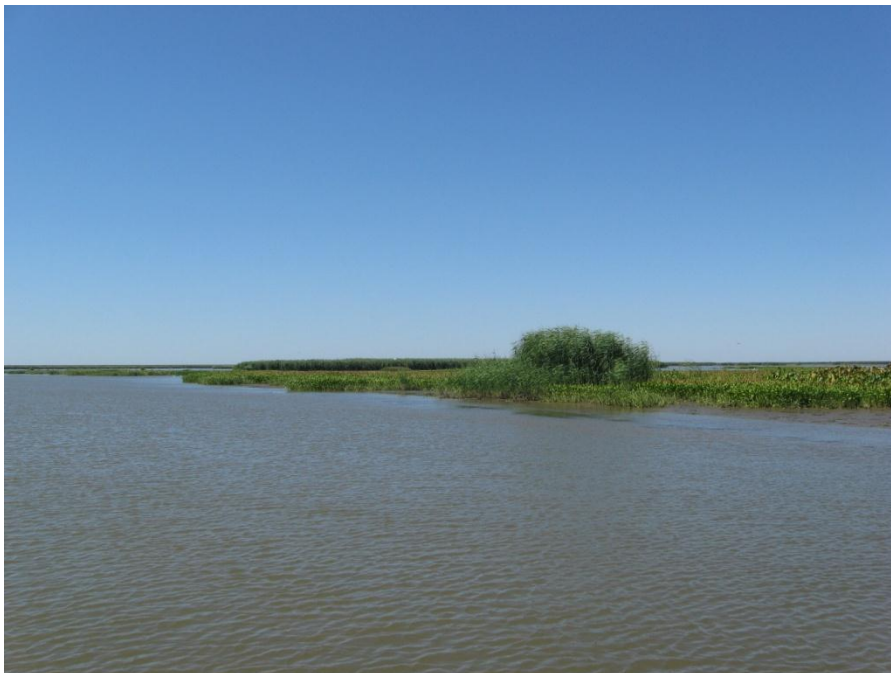
Crevasse No. 12, (view 2) Looking west. Vegetated Spoil area in center of view.

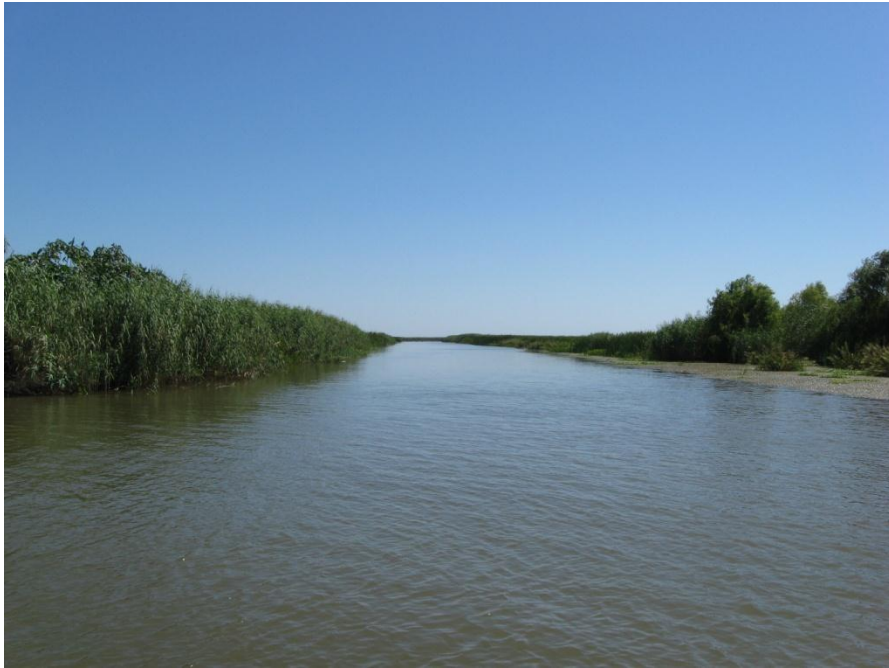
- D. Crevasse No. 11: (2,600 ft. X 100 ft. X -8.0 ft. NAVD 88) This re-dredged crevasse (1999) has maintained a good flow throughout its length. Soundings indicate that it has maintained over 80% of its original depth throughout, which is partly due to the current in this cut being more than adequate. All of the spoil deposited in the inner lagoon areas has vegetated very heavily and appears to be in excellent condition. The last three years of high water allowed much sediment to enter the interior marshes.

Crevasse No. 11, (view 1) Looking in from Pass a Loutre.  
Crevasse has maintained its constructed width throughout.

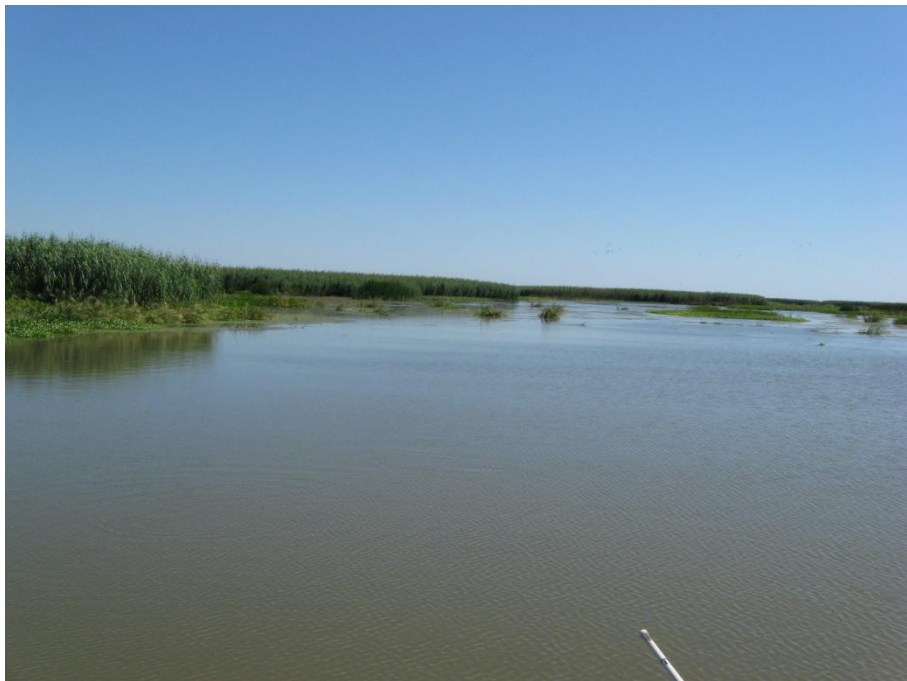
Crevasse No. 11, (view 2), Heavily vegetated crevasse  
dredging spoil in bay area, foreground.

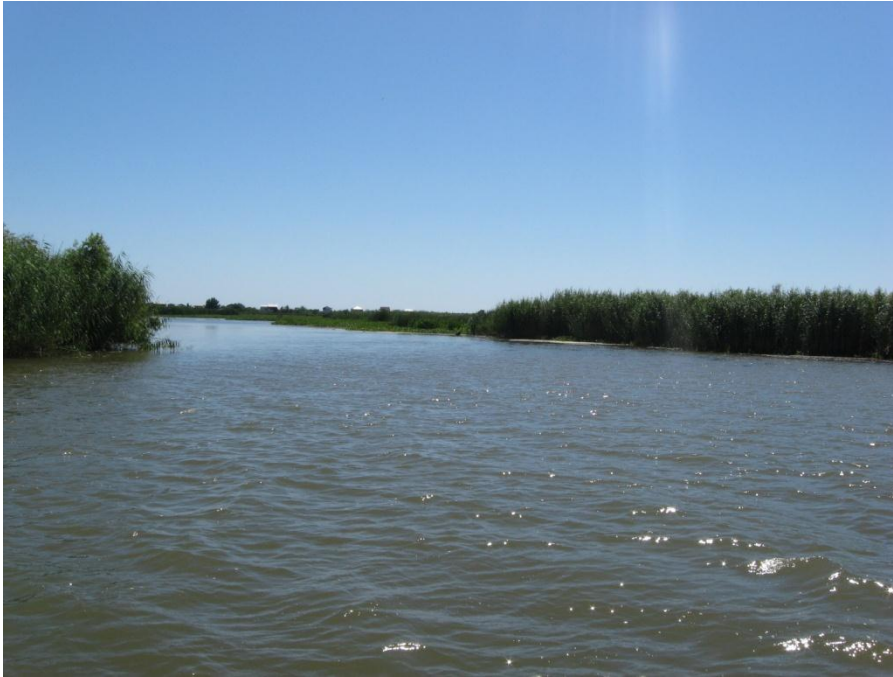
- A. Crevasse No. NC-1: (1,000 ft. X 100 ft. X -8.0 ft. NAVD 88) This 2005 new-crevasse appears to be in good condition. Soundings indicate that it has retained slightly more than half of its originally constructed depth. The interior indicates that river water is flowing very well through the channel carrying large amounts of sediment, and the spoil from the dredging of the crevasse is heavily vegetated throughout the deposited bay area.

Crevasse No. NC-1, (view 1) Looking south. Notice heavily vegetated construction easement from crevasse dredging.

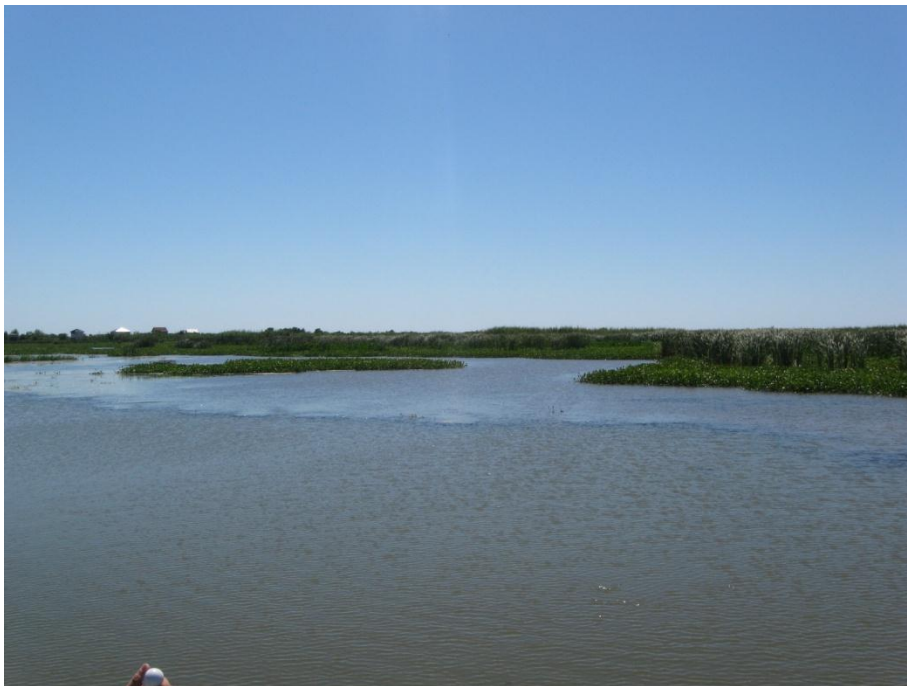
Crevasse No. NC-1, (view 2) Vegetated spoil deposition in inside bay area, and also large amounts of heavy sediments.

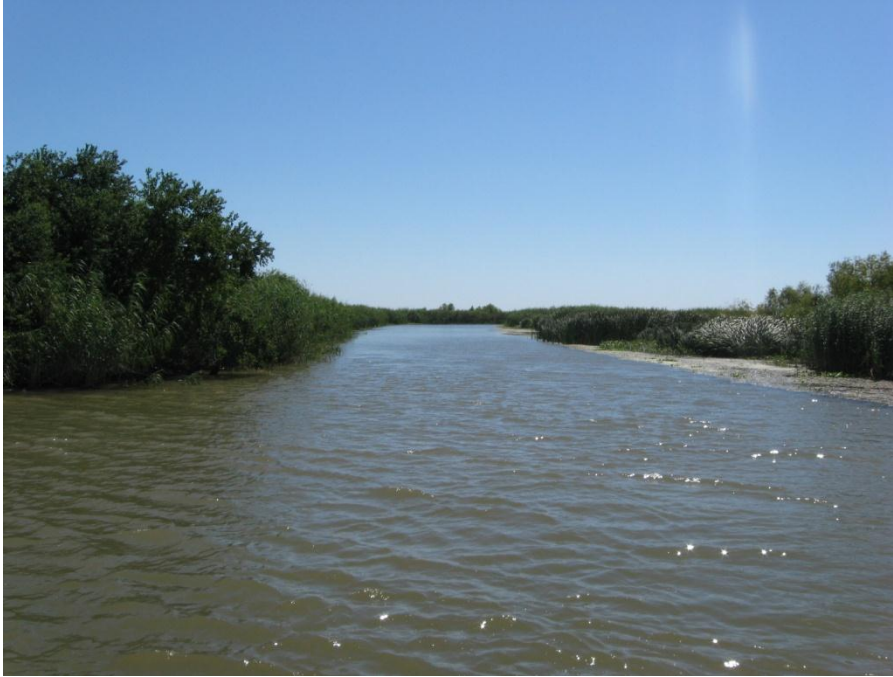
- C. Crevasse No. 9: (2,200 ft. X 75 ft. X -8.0 ft. NAVD 88) Good flow is being maintained in this dog-leg shaped previously dredged crevasse (1999). Its location allows for swift currents during the present high river stages. Soundings indicate that this crevasse has maintained 75% of its original depth throughout its length. The spoil deposition from this cut is very heavily vegetated and seems to have increased in size by the sediments flowing into the area.

Crevasse No. 9, (view 1) From Pass-a-loutre looking south into crevasse. Original width has been maintained.

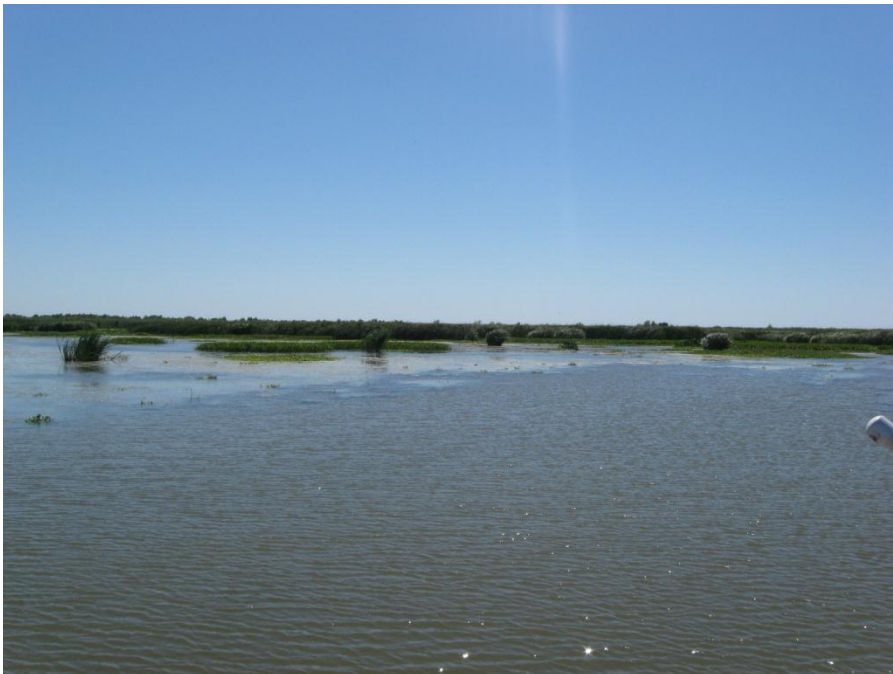
Crevasse No. 9, (view 2) Crevasse end looking at spoil area vegetation and huge amounts of sediments from the pass.

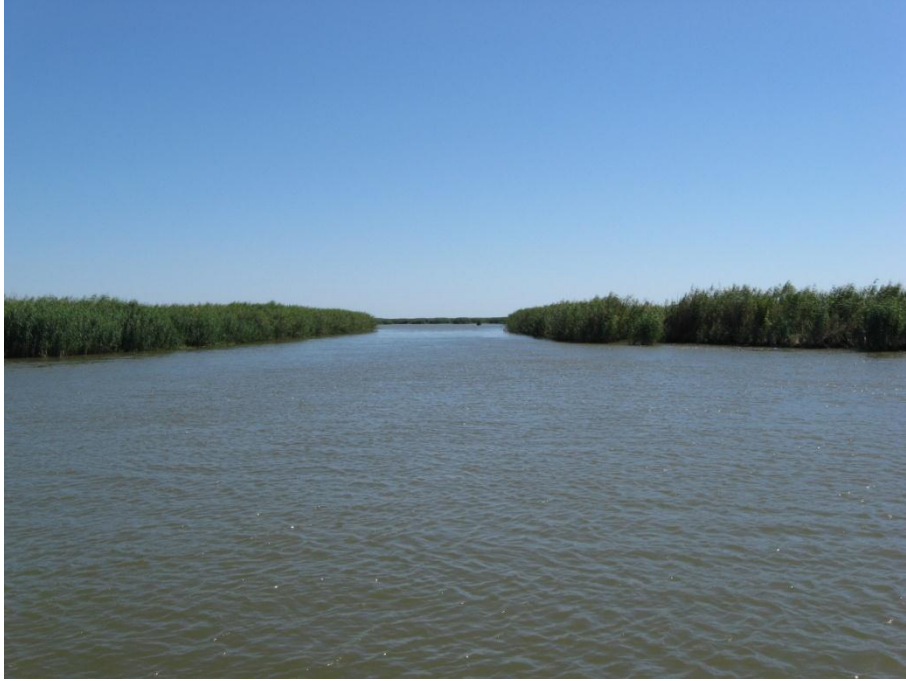
- B. Crevasse No. NC-3: (1,400 ft. X 100 ft. X -8.0 ft. NAVD 88) This is the second of the two new 2005 crevasses and the only one on Main Pass. It is functioning very well, and flowing with a very swift current bringing much needed sediments into the interior bays. Our soundings show that the crevasse is maintaining its original depth throughout its channel length and the spoil from the crevasse dredging has completely vegetated. New spoil deposits from this high water season can also be seen in the inner bay.

Crevasse No. NC-3, (view 1) Looking into crevasse from South Pass showing heavy vegetation on both banks.

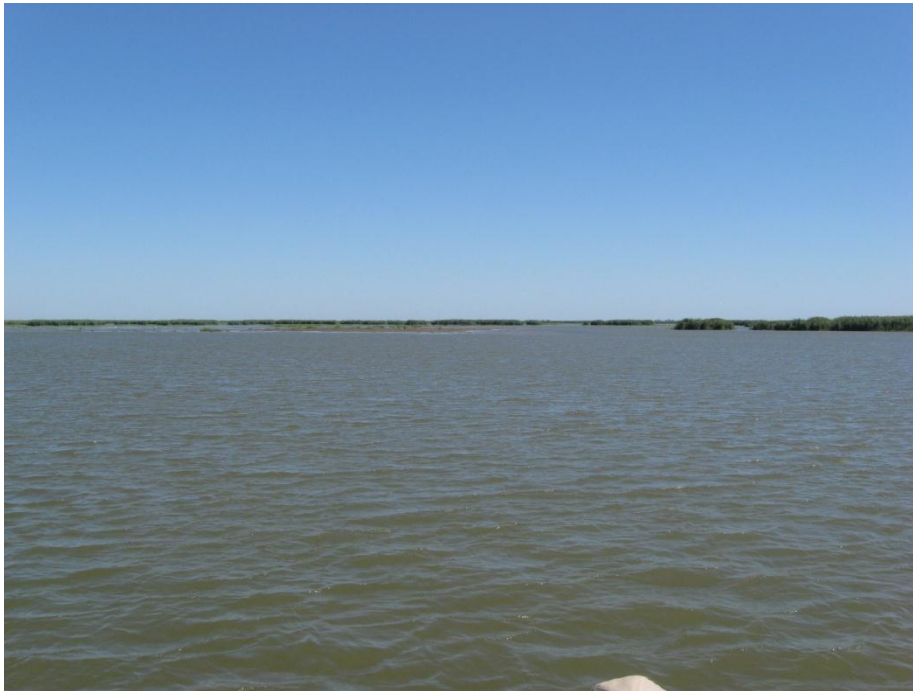
Crevasse No. NC-3, (view 2) Inside crevasse looking east into open bays. Notice heavy material buildup in center of view. This crevasse has maintained all of its original dimensions.

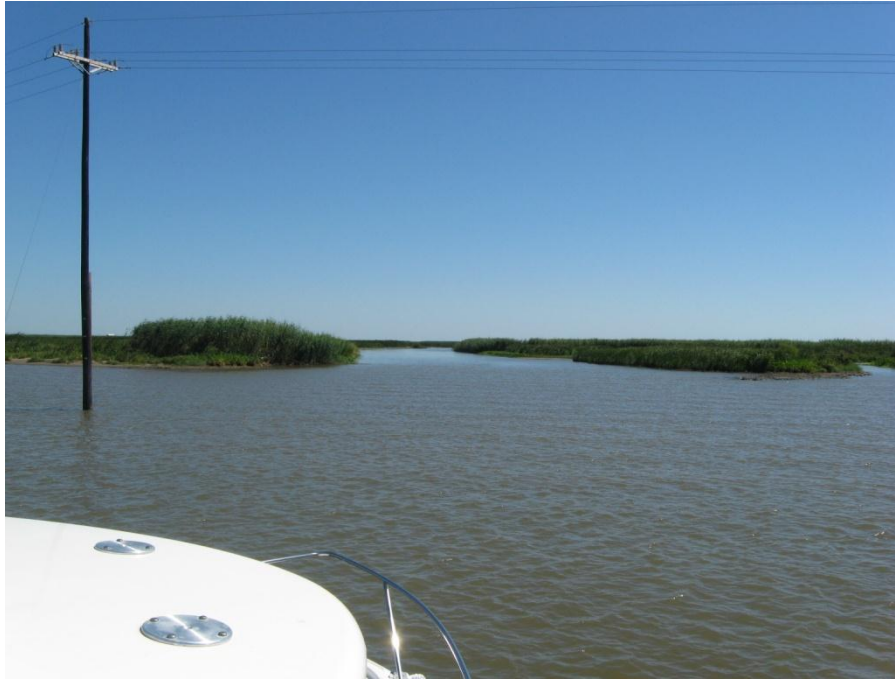
- F. Crevasse No. 81: (1,200 ft. X 100 ft. X -8.0 ft. NAVD 88) This crevasse is located off of Baptiste Colette in the Delta Wildlife Management Area. The current in the crevasse is strong, since it is located in close proximity to the Mississippi River. Despite soundings indicating that the mouth of this crevasse has silted up from the large amounts of sediments moving into the cut by the river currents, there is still some sediments being carried into the interior marsh area.

Crevasse No. 81, (view 1) Looking south from Baptiste Collette channel. Material build-up at channel edge prevented the inspection team from entering the channel.

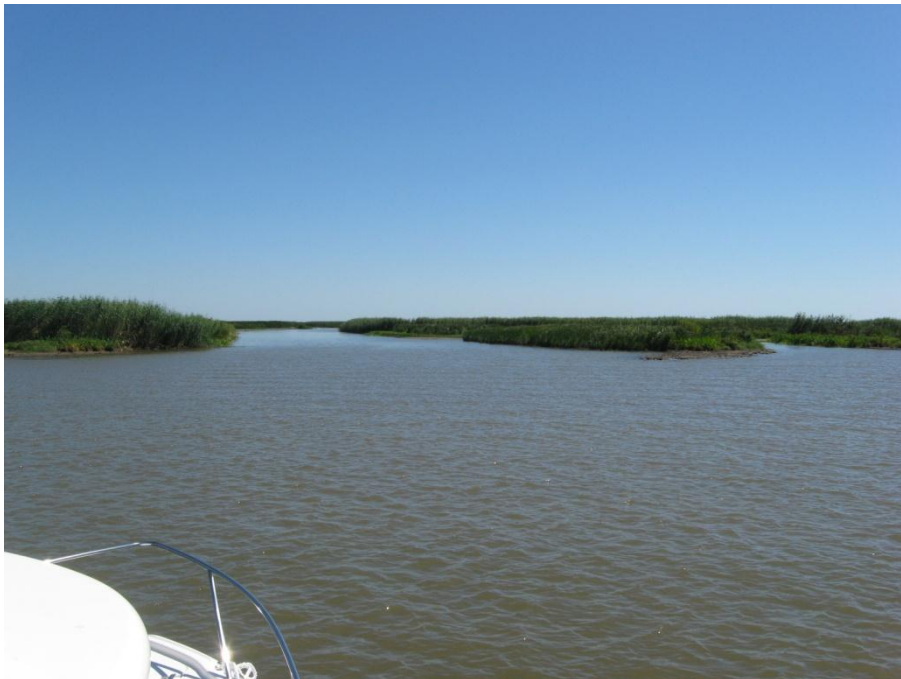
Crevasse No. 81, (view 2) Crevasse showing heavy amount of vegetated spoil area and newly deposited sediments.
